# **Arborist Report for the Sacramento Commons Project Site, City of Sacramento, California**

OCTOBER 15, 2014

*Revised DECEMBER 22, 2014*

**AERIAL INSPECTION AND RISK ASSESSMENT,  
FIVE ELM TREES, SACRAMENTO COMMONS  
SACRAMENTO, CALIFORNIA**

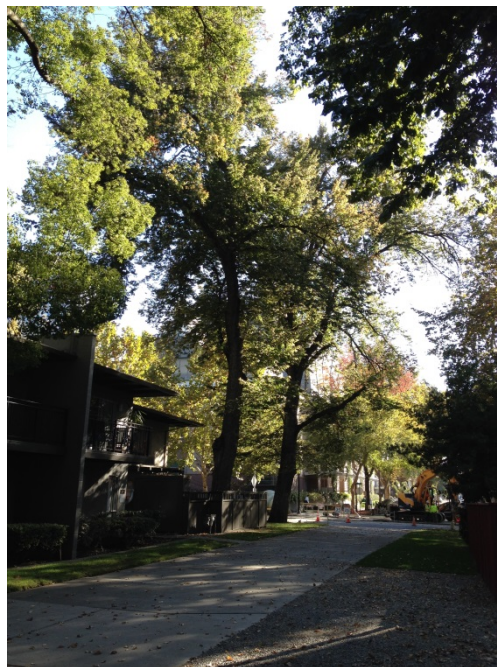
Photo 6: Two Heritage Trees (American elm trees, #66 and 67) in the southern portion of the project site.

- Implement Tree Associates (Appendix D) recommendations for Heritage Trees #66, 67, and 76 during site preparation and continue inspections every 2-3 years and after major storms.

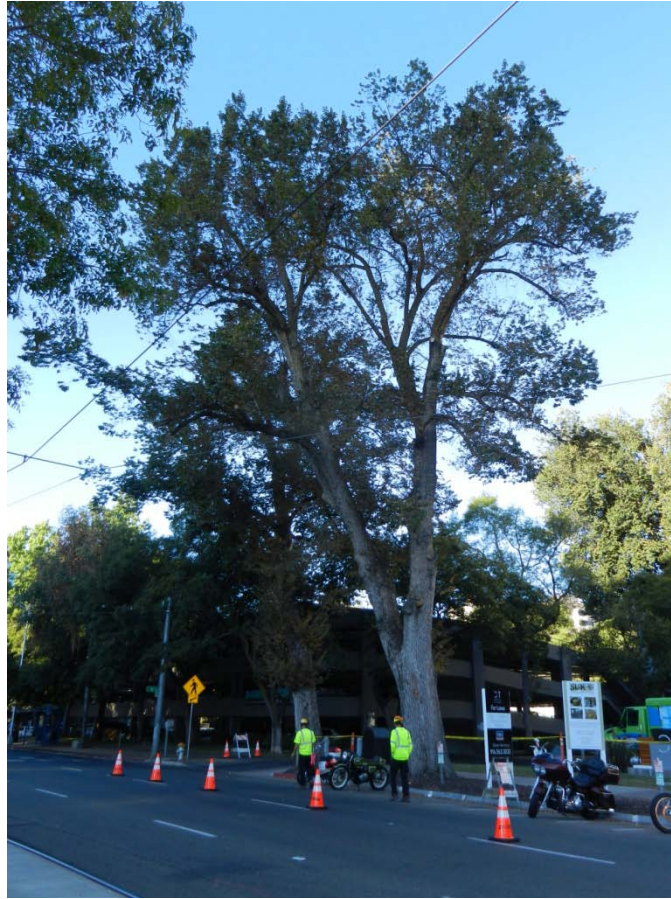
**Figure 1. Looking southeast at Tree #49.**

49	<i>Ulmus americana</i>	American elm	1	47.2				47.2	80	40	Fair	Fair	Street Tree	None	1,963	14,334	9,492	395	85	Broken limb in canopy, canopy dieback, lean, cavity, prune and inspect as recommended in Appendix D
50	<i>Ulmus americana</i>	American elm	1	35.3				35.3	50	40	Fair	Fair	Street Tree	None	1,735	11,104	4,728	264	66	Lean, arching form, canopy dieback, prune and inspect as recommended in Appendix D
51	<i>Ulmus americana</i>	American elm	1	10.0				10.0	40	15	Fair	Fair	Street Tree	None	616	5,229	230	44	31	Small narrow canopy
53	<i>Acer buergerianum</i>	Trident maple	1	8.0				8.0	25	15	Good	Fair	Street Tree	None	638	3,261	174	39	19	Included bark, asymmetrical canopy
54	<i>Pyrus calleryana</i>	Bradford pear	1	16.0				16.0	22	20	Fair	Fair	Street Tree	None	1,452	2,645	817	86	16	Heavy lean/arch over street
55	<i>Zelkova serrata</i>	Zelkova	1	32.2				32.2	50	40	Good	Good	Street Tree	None	4,778	9,557	4,590	287	57

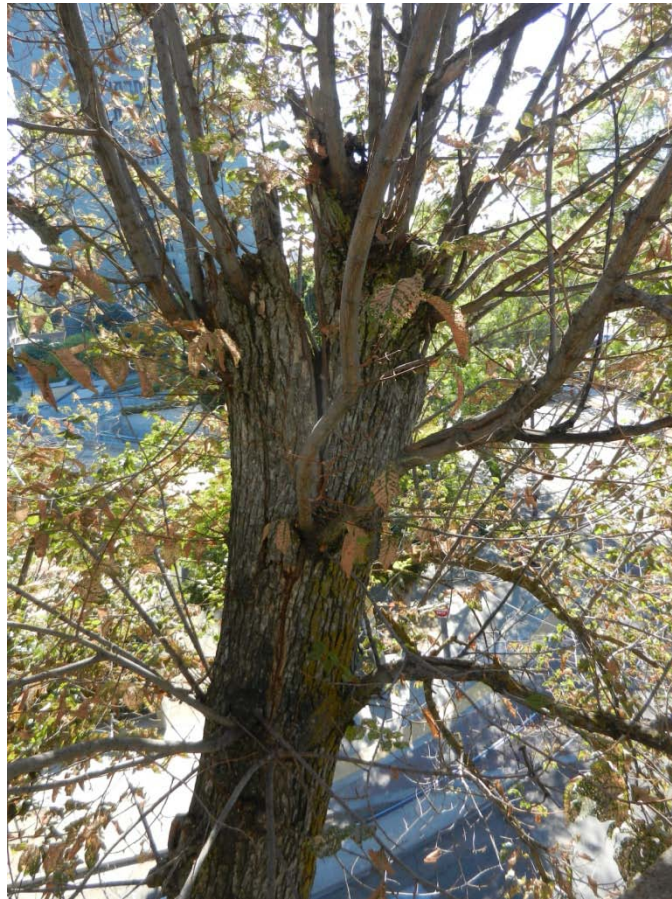
- South-facing codominant secondary trunk off southeast-facing trunk has previous breakout(s) near top with extensive decay (Figure 2).
- South-facing codominant secondary trunk on north-facing trunk with previous breakout and extensive decay where topped many years ago (Figure 3). As little as 2 inches of sound wood exists just below attachment point of up to 13-inch diameter limbs. Likelihood of limb failure is probable<sup>1</sup>.

**Figure 2. Breakout on south facing codominant secondary trunk on southeast facing trunk with extensive decay.**

Following the above recommendations should reduce the likelihood of limb failure to possible.

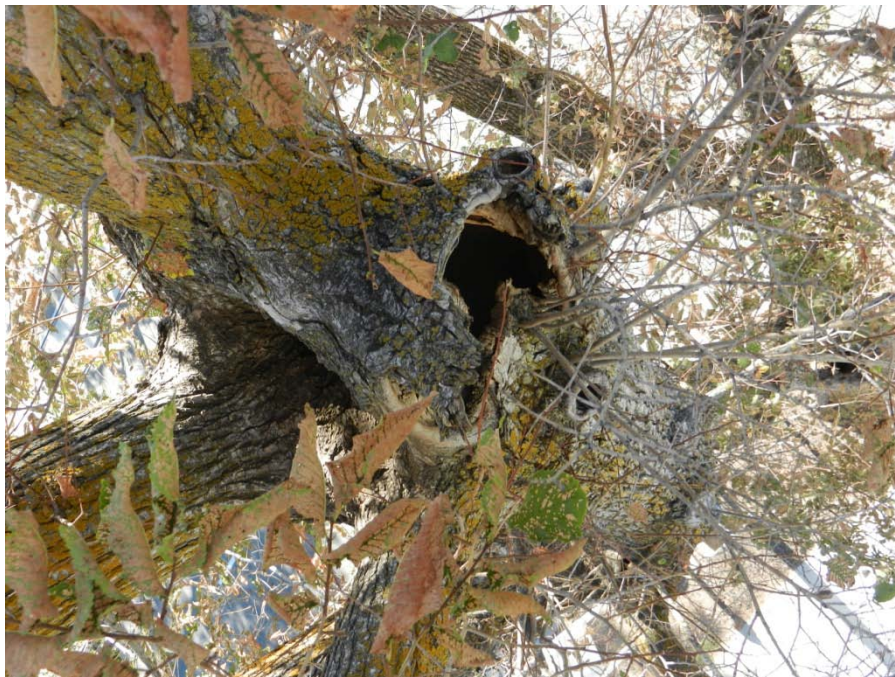
**Figure 3. Looking down on south facing codominant secondary trunk on north-facing trunk. Note previous breakout, cavity and extensive decay.**

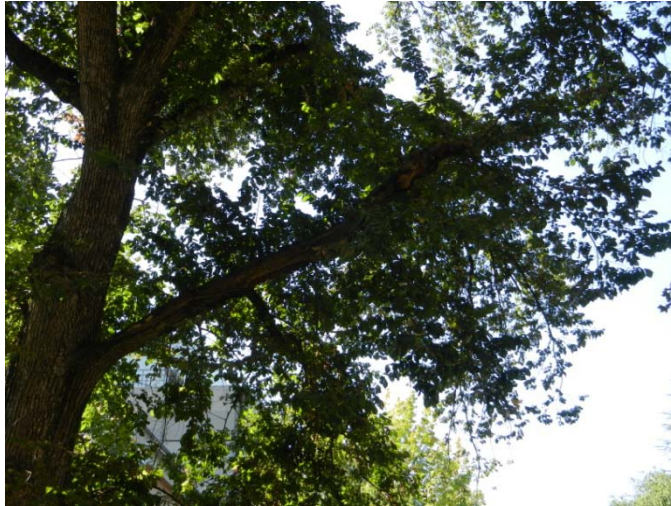
**Figure 6. West facing primary limb at 15 feet with wound and decay on upper side of limb.**

- Remove dead and broken limbs.
- On north trunk, use reduction cuts to remove 30% of the foliage on trunk.
- On north facing codominant trunk, use reduction cuts to remove 30-50% of the foliage on primary limbs over apartments.
- Remove west facing primary limb at 15 feet.
- Remove west facing primary limb at 55 feet on south facing trunk.
- Use reduction cuts to remove the following percentage of foliage/buds on the limbs below:
  - Primary facing south attached at 30 feet on south trunk – 50%, up to 5" dia. cuts;
  - Primary facing southeast at 40 feet on south trunk – 25%;
  - Primary facing south at 60 feet on south trunk -20%.
- Repeat aerial inspection within two years or after major storms.

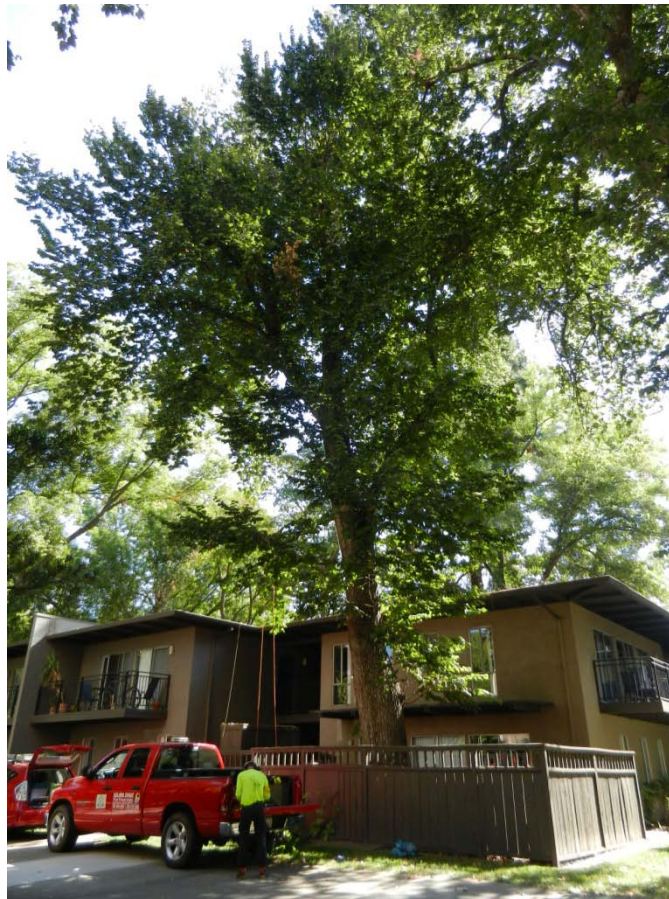
**Figure 7. Looking northeast at Tree #67.**

67	<i>Ulmus americana</i>	American elm	1	48.0				48.0	80	40	Fair	Fair	Heritage Tree	None	2,643	18,495	9,882	405	110	Dead wood in canopy, canopy dieback, possible decay in old pruning cut at 15 feet, tree behind private fence (diameter estimated, not measured), prune and inspect as recommended in Appendix D
68	<i>Ulmus americana</i>	American elm	1	50.6				50.6	80	40	Fair	Fair	Non-Heritage Tree	None	3,632	24,332	11,215	435	145	Basal wound at 4 feet, cavities in major limbs at 25 and 30 feet, minor canopy dieback, narrow stem attachments, included bark - recommend further inspection
69	<i>Fraxinus velutina</i>	Modesto ash	1	38.4				38.4	80	45	Fair	Fair	Heritage Tree	None	2,828	14,985	5,383	262	89	Cavity at 8 feet, poor branch attachment, canopy dieback, epicormic sprouting
71	<i>Casuarina spp.</i>	Beefwood	1	36.4				36.4	60	30	Fair	Poor	Non-Heritage Tree	Remove - Construction	1,104	9,940	2,733	138	65	2 main stems, narrow stem attachment, 1 main stem topped, included bark, trunk cavity

- Remove dead and broken limbs.
- Use reduction cuts to remove the following percentage of foliage/buds on the limbs below:
  - East facing primary attached at 40 feet – 30%;
  - Secondary attached at 45 feet on northeast facing primary attached at 35' – 15%;
  - Secondary off primary facing north attached at 35' – 15%.
- Re-inspect tree for pruning needs within three years or after major storms.

Following the recommendations above should reduce the likelihood of limb failure.

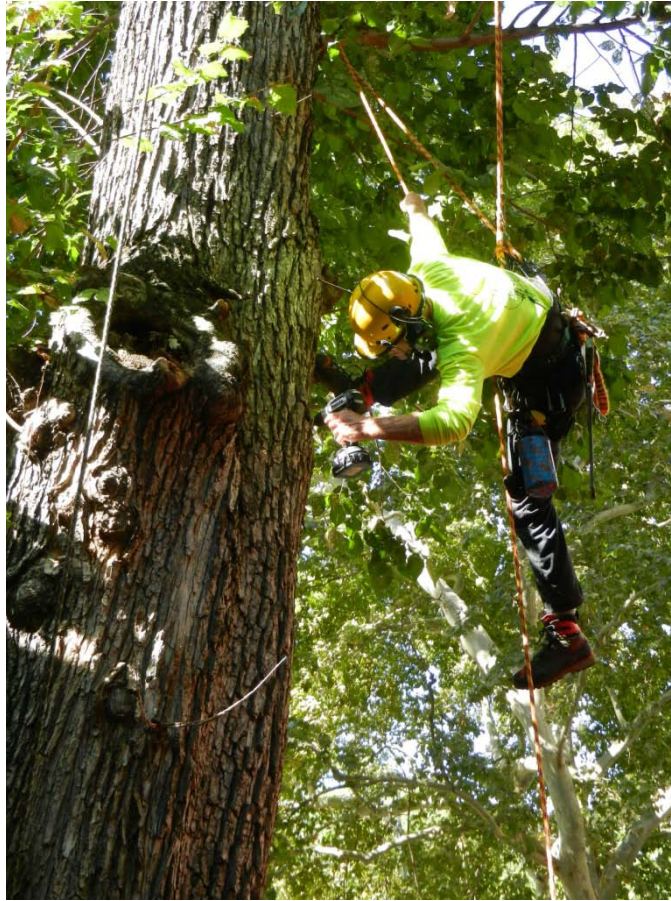
**Figure 8. Rhett Richardson, Owner of Solano Shade Tree Preservation drilling to determine sound wood thickness near large wound with decay.**

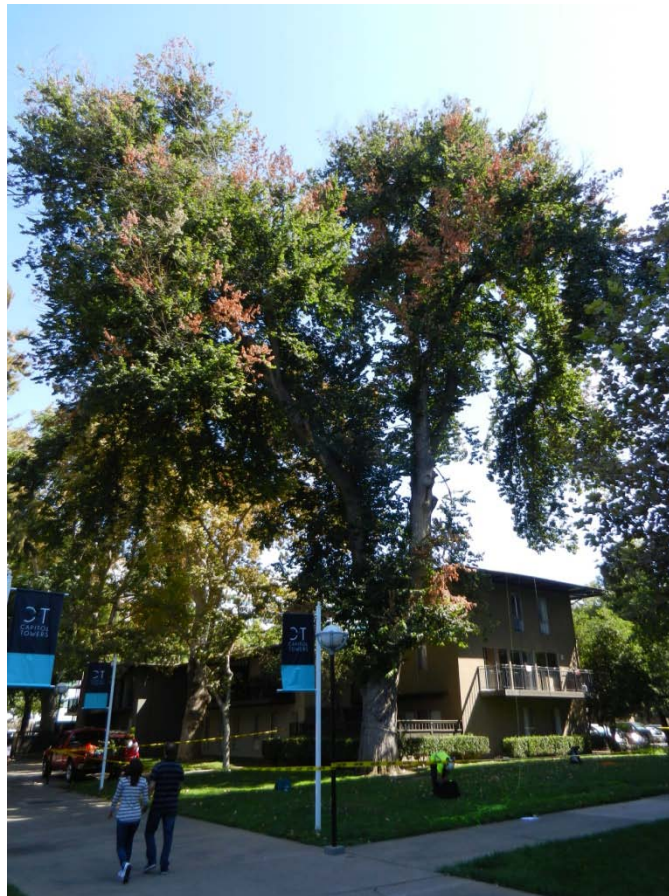
**Figure 9. Looking northeast at Tree #76. Note wilted foliage caused by squirrel damage.**

- Remove secondary limbs facing north attached at 65 feet on east-facing primary immediately.
- Shorten south-facing primary attached at 30 feet by 20 feet (heading cut).
- Use reduction cuts to remove the following percentage of foliage/buds on the limbs below:
  - East-facing primary attached at 35 feet – 30%, max 7" diameter cuts;
  - Northwest-facing primary attached at 15 feet – 30%, max 6" diameter cuts;
  - Secondary at 50 feet on east facing primary attached at 35 feet – 30%.
- Remove dead and broken limbs.
- Repeat aerial inspection within two years or after major storms.

Following the recommendations above should reduce the likelihood of limb failure to possible.

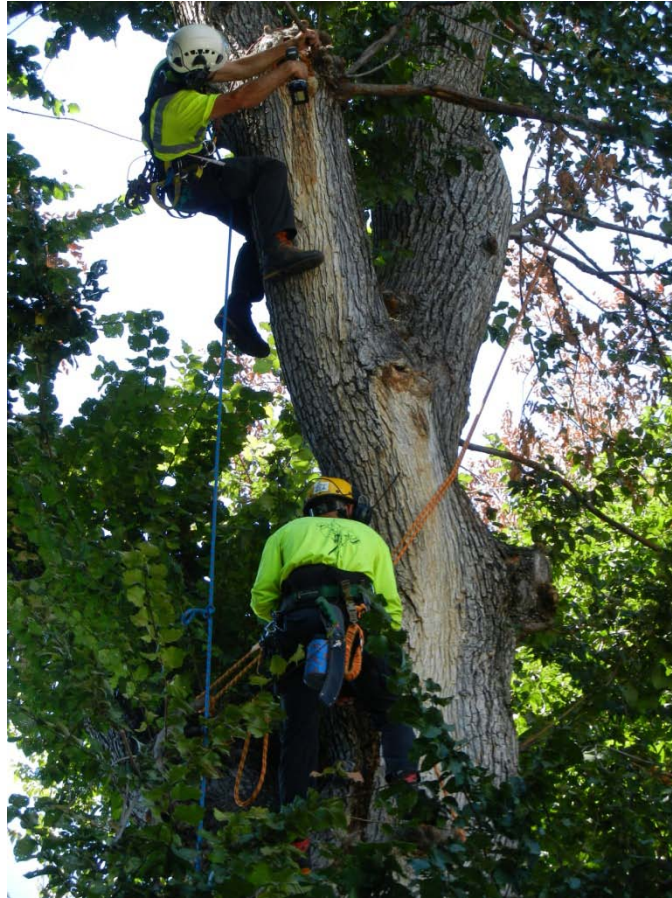
**Figure 10. Justin and Rhett inspecting cavities with decay on Tree #76.**

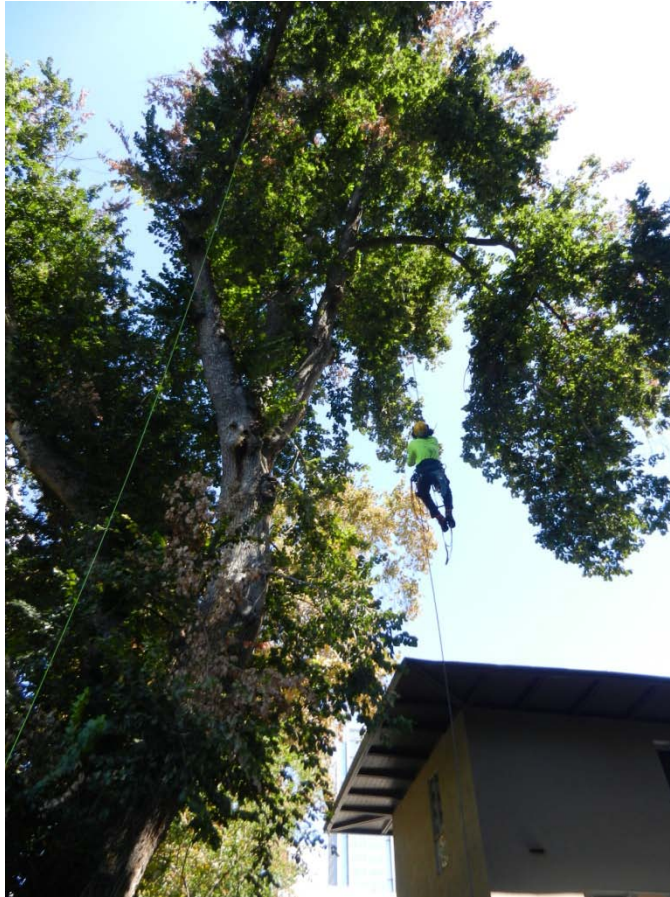
**Figure 11. Secondary limbs hanging over apartments (above climber) are cracked and have an imminent likelihood of failure.**
