# ALLEYS & BULB-OUTS

# Downtown Infrastructure Study - Alleys Plan

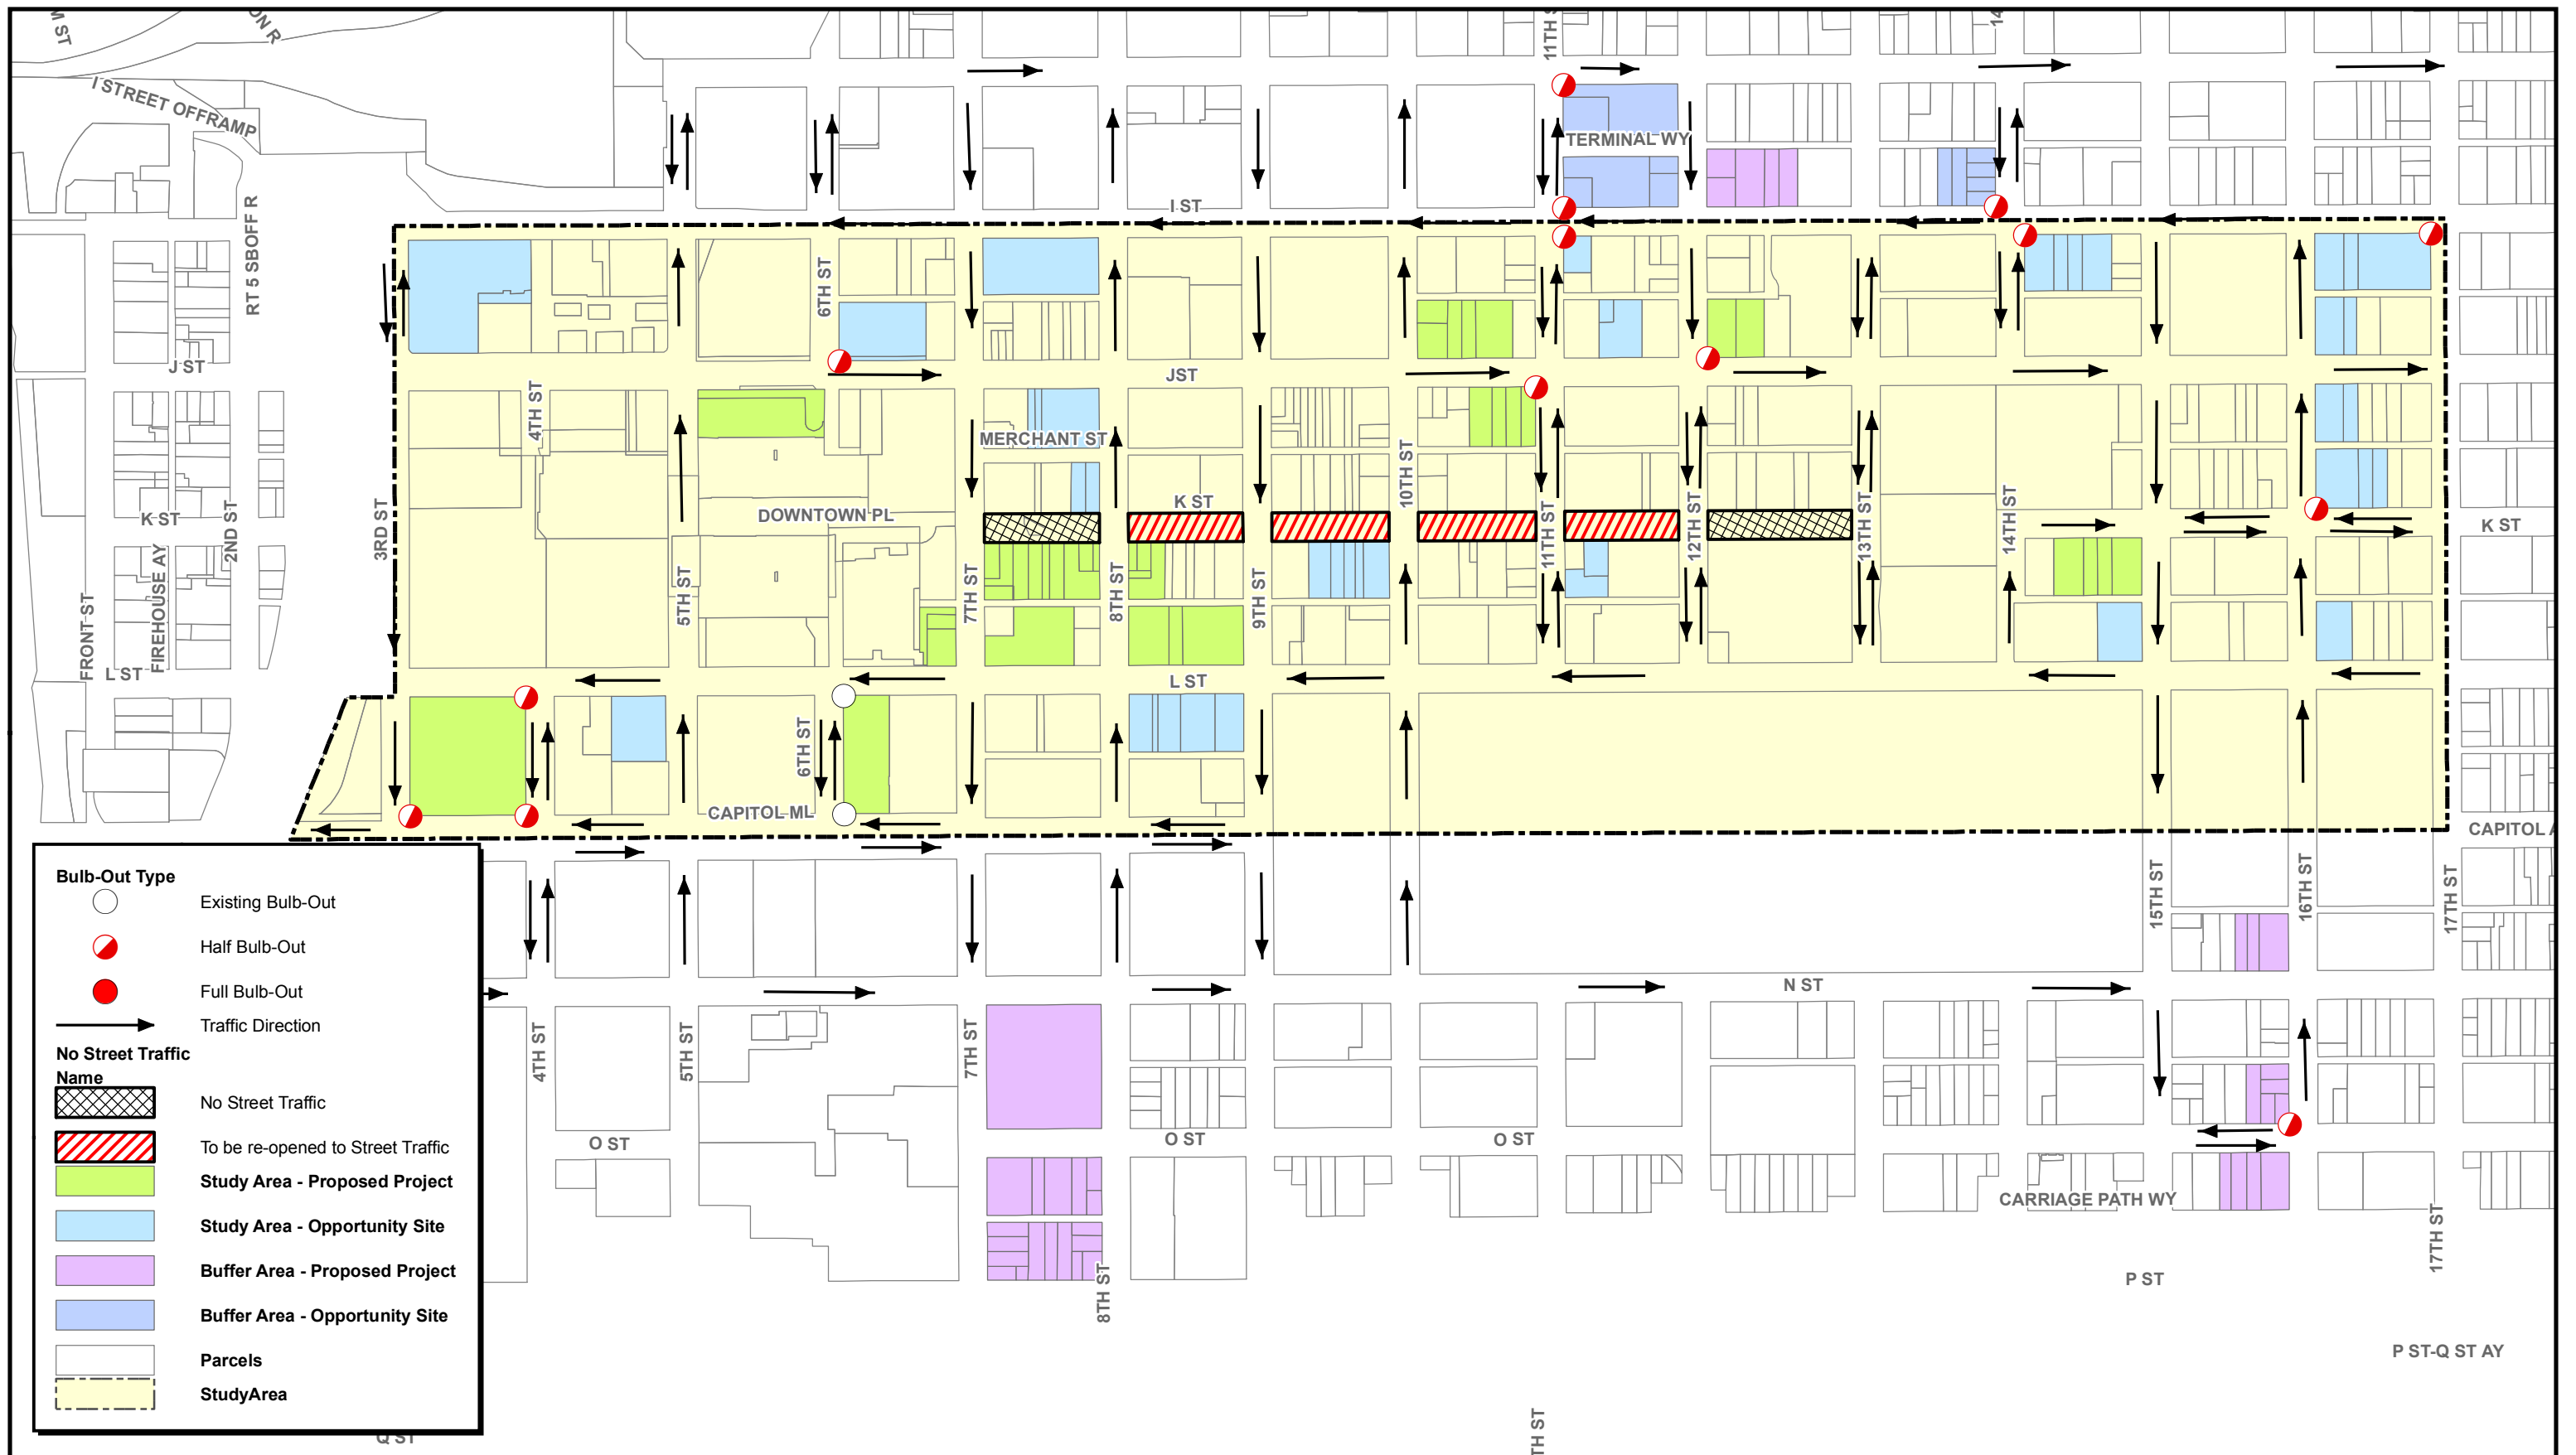
FIGURE III-2

# Downtown Infrastructure Study - Bulb-Out Plan

The locations of the anticipated bulb-outs within the Study Area are depicted on Figure III-2. The bulb-out designs shown in this Report are intended to provide initial guidance/planning level detail only. Final bulb-out design and locations are subject to review and approval of the City Traffic Engineer. Each project specific bulb-out designs will need to consider the following to ensure traffic and pedestrian safety.
